IDENTIFYING COMMON MIG TORCH FAULTS

Technical advice in the original SifTips style which started in 1932.

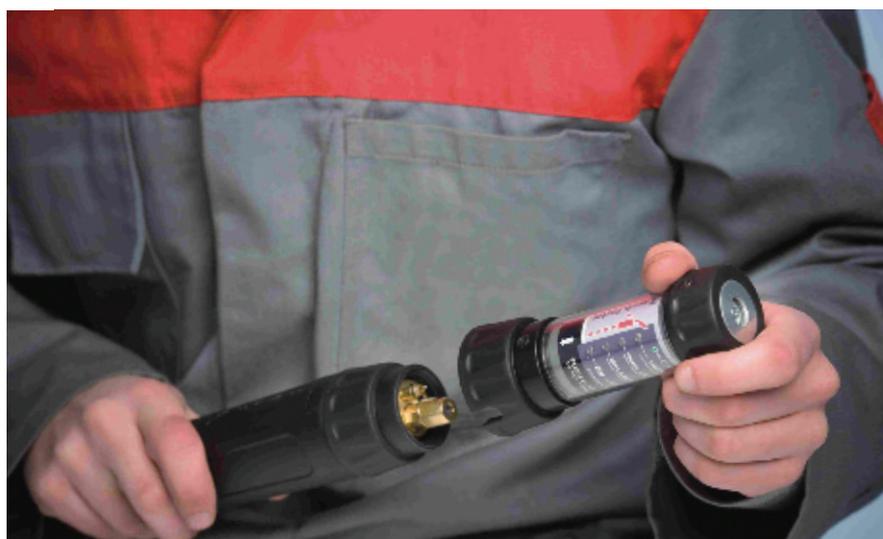
The MIG Torch tester is an all-in-one tool, which allows for quick and effective testing for common faults developed within the MIG torch during day-to-day use. The unit is pocket size and battery operated, so can be used anywhere.

The MIG Torch Tester carries out a diagnostic cycle and will indicate any irregularities to allow the operator/engineer to identify any fault quickly, reducing the need for returning defective torches to a service centre.

By simply inserting the Euro fitting into one end of the MIG Torch Tester and then resting the contact tip on the other then the unit can test:

All of the above issues can be quickly and easily established with the Weldability-Sif MIG Torch Tester.
